ISFS operations for RELAMPAGO

Document Version Control

Version	Date	Description
V1.0	28 Feb 2020	First release of final data
V2.0	20 Jan 2021	Corrections to the NR01 radiometers. See below

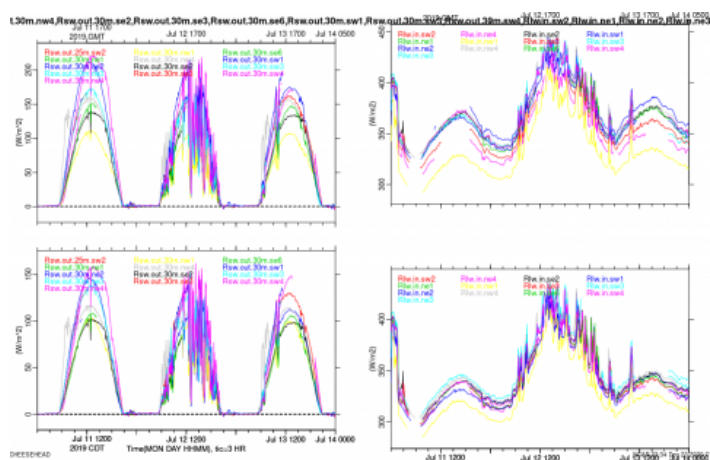
An error was discovered in the NR01 radiometer measurements. Coefficients provided by the manufacturer and unique to each sensor were swapped for the Rsw.out (outgoing shortwave radiation) and Rpile.in (radiant heat within the radiometer dome) parameters. This also affects the derived parameters Rlw.in (incoming longwave radiation) and Rsum (the total of all 4 components) - refer to <https://www.eol.ucar.edu/node/1935> for the calculation. The plot below is a test example from the CHEESEHEAD campaign with the upper left Rsw.out and upper right Rlw.in before correction, and the bottom row after correcting for this switch.

Sensors with serial numbers greater than 14 are affected and require correction, i.e. apply the correct coefficients for Rsw.out and Rpile.in parameters and update the measured values, including derived Rlw.in and Rsum. Refer to the Table below for a list of the site, associated NR01 serial number, and whether corrections are required.

These measurements have been corrected for the 5-minute averaged data files (now version 2.0), and are available at the EOL Field Data Archive: <https://doi.org/10.26023/ZPHJ-JW9W-2B0Y>
