ISFS Operations at CHEESEHEAD

Hukseflux NR01 Issue First Documented Wed, Dec 23, 2020.

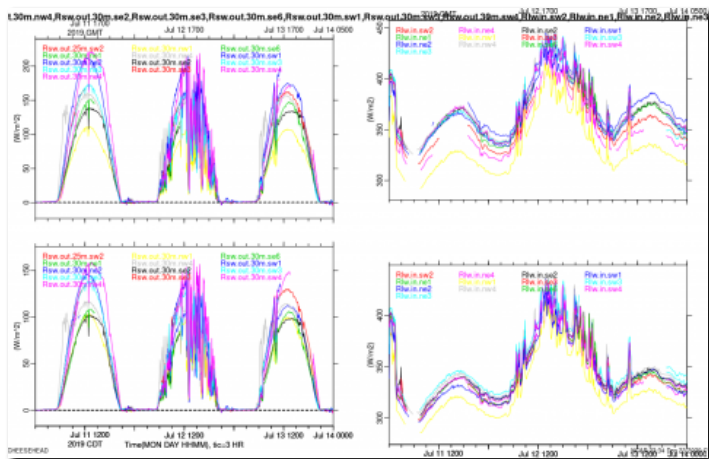
An error was discovered in the NR01 radiometer measurements. Coefficients provided by the manufacturer and unique to each sensor were swapped for the R_{sw.out} (outgoing shortwave radiation) and R_{pile.in} (radiant heat within the radiometer dome) parameters. This also affects the derived parameters R_{lw.in} (incoming longwave radiation) and R_{sum} (the total of all 4 components) - refer to <https://www.eol.ucar.edu/node/1935> for the calculation. The plot below is a test example from the [CHEESEHEAD](#) campaign with the upper left R_{sw.out} and upper right R_{lw.in} before correction, and the bottom row after correcting for this switch.

Sensors with serial numbers greater than 14 are affected and require correction, i.e. apply the correct coefficients for Rsw.out and Rplw.in parameters and update the measured values, including derived Rlw.in and Rsum. Refer to the Table below for a list of the site, associated NR01 serial number, and whether corrections are required.

These measurements have been corrected for the 5-minute averaged data files (now version 2.0), and are available at the EOL Field Data Archive:
