Update: May 24, 2023, with High Rate (25 sps) Data Notes

CONTRAST Project Manager Report Aircraft payload

CONTRAST GV payload

11/22/2013

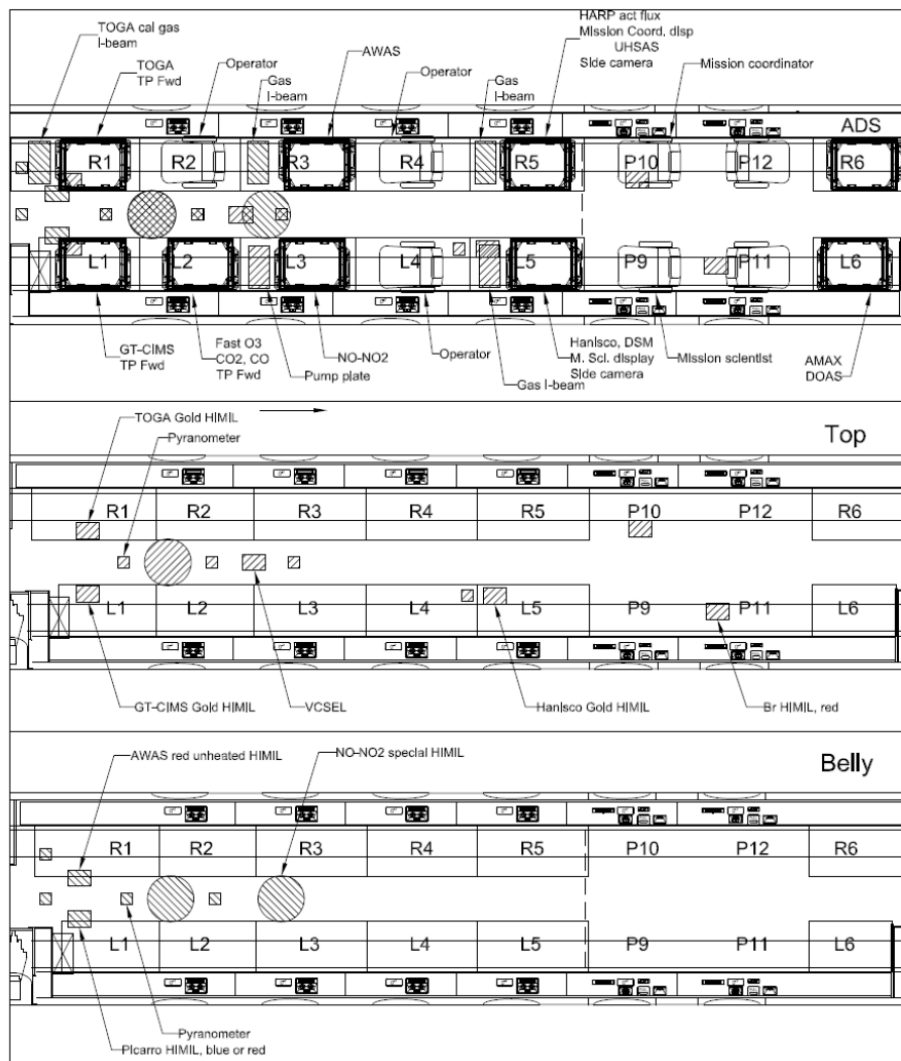
- VCSEL
- Fast O3
- NO-NO2
- VUV CO
- Picarro CO2,
- CH4
- CH2O
- GT-CIMS
- AMAX-DOAS
- Br (BRIGHT)
- AWAS
- TOGA
- UHSAS
- 2D-C
- CDP
- HARP
- Mission coord.
- Mission sci.
- Gas cylinder rack
- Gas I-beam, x4
